## Application: Tap Changer

ISOPur Fluid Technologies eliminates carbon buildup in transformer oil and greatly reduces oil turn-over, saving the company man-hours and money

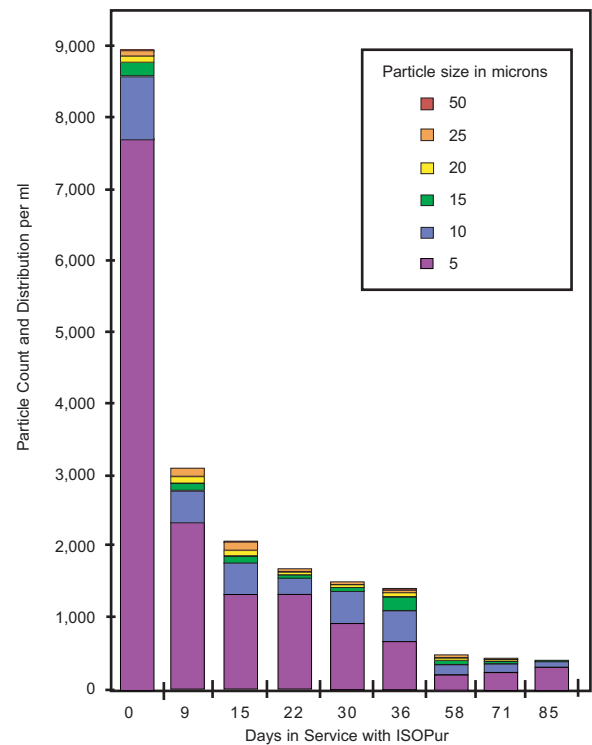
Graph 1: Original Transformer Oil Analysis

Gas-in-oil Analysis - Days in Service vs. Gas Type

0	9	15	22	30	36	58	71	85
Hydrogen:	0.1	20	32	49	69	78	105	171	0.5
Oxygen:	22,300	26,000	28,100	11,400	26,200	10,400	22,100	26,500	12,000
Nitrogen:	44,100	56,400	60,800	25,500	56,400	23,200	41,700	60,600	27,800
Methane:	0.1	3	7	8	22	21	44	78	39
Carb.Monoxide:	0.1	0.1	2	21	63	74	96	230	94
Carb. Dioxide:	208	91	81	181	55	77	80	86	86
Ethane:	0.1	0.1	1	0.1	3	2	7	13	6
Ethylene:	1	10	14	12	41	31	90	158	84
Acetylene:	8	44	56	42	114	79	248	398	244
T.C.G.	9	77	112	131	312	285	590	1,048	467

All figures are parts per million - 0.1 = < 0.5 ppm or non detectable  
T.C.G. = Total Combustible Gases

Con Edison had previous experience using ISOPur's Balanced Charge Purification (BCP) technology. Graph 1 shows the results of an oil analysis test conducted in the 1990's.

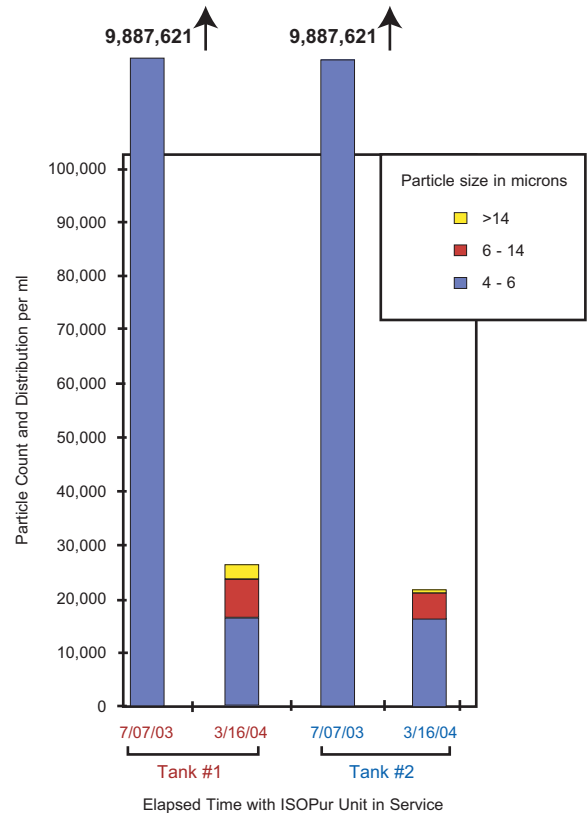
Graph 2: Con Ed Transformer Oil Tank Analysis

Graph 2 shows the positive effect on the carbon contamination as well as on the entire transformer oil system. In addition, the physical condition of the fluid has improved after less than a year of purification. Oil samples were taken at installation and then again 10 months later.

More recently, in July 2003, ISOPur installed two purification systems in a kidney loop on each of two dedicated 2000 gallon fluid reservoirs. Immediately following start-up of the IOSPur systems there was a positive effect not only on the carbon contamination but the entire transformer oil system.

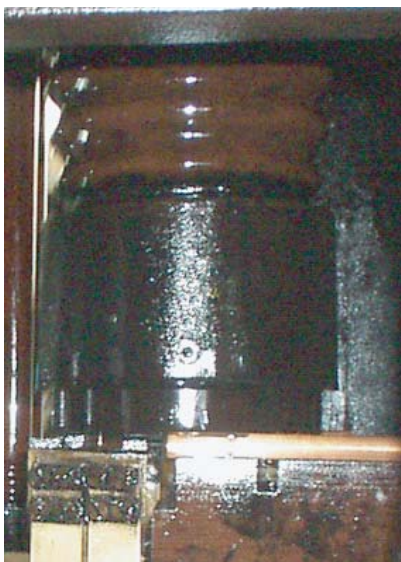
Figure 1: Before ISOPur (taken 04/03)

Figure 1 is the tap changer before the Balanced Charge Purification (BCP) technology was implemented. Note the carbon and sludge found on the base and on the screw plate contact points.

When the tap changers were opened for servicing, there was visible evidence of a significant reduction of carbon buildup on the insulators and more importantly on the contact points (see Figures 1 & 2).

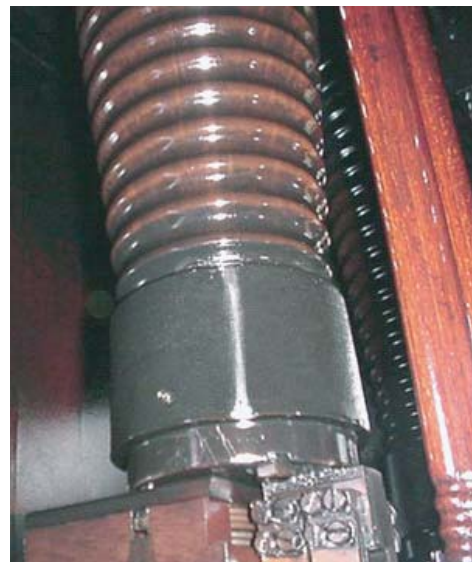
Figure 2: After ISOPur (taken 04/04)

Figure 2 is the tap changer after 10 months of continual oil purification with the ISOPur system. Note the clean appearance and removal of carbon contamination. Sludge has also been removed from the contact points, leaving them scoured and shiny.
