Effective Gas Turbine Varnish Clean-up & Oil Conditioning

ISOPur Fluid Technologies reduces turbine trips by purifying lube oil and removing varnish

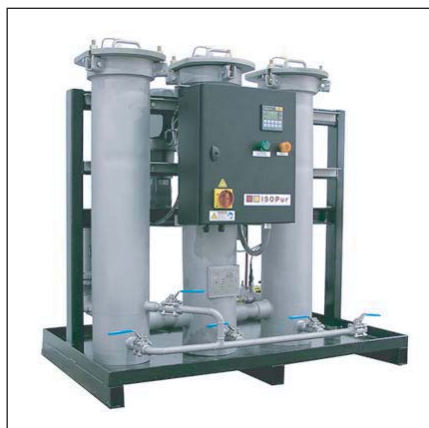
HR-Series

- Variable flow
- Viscosity: 220cSt @ 40C
- Explosion proof option
- Fluid temp: 65 to 200 F

HR capacity: 1200 GPH
MR capacity: 600 GPH
